January 25, 2022

# Victorian Big Battery Fire: July 30, 2021

## REPORT OF TECHNICAL FINDINGS

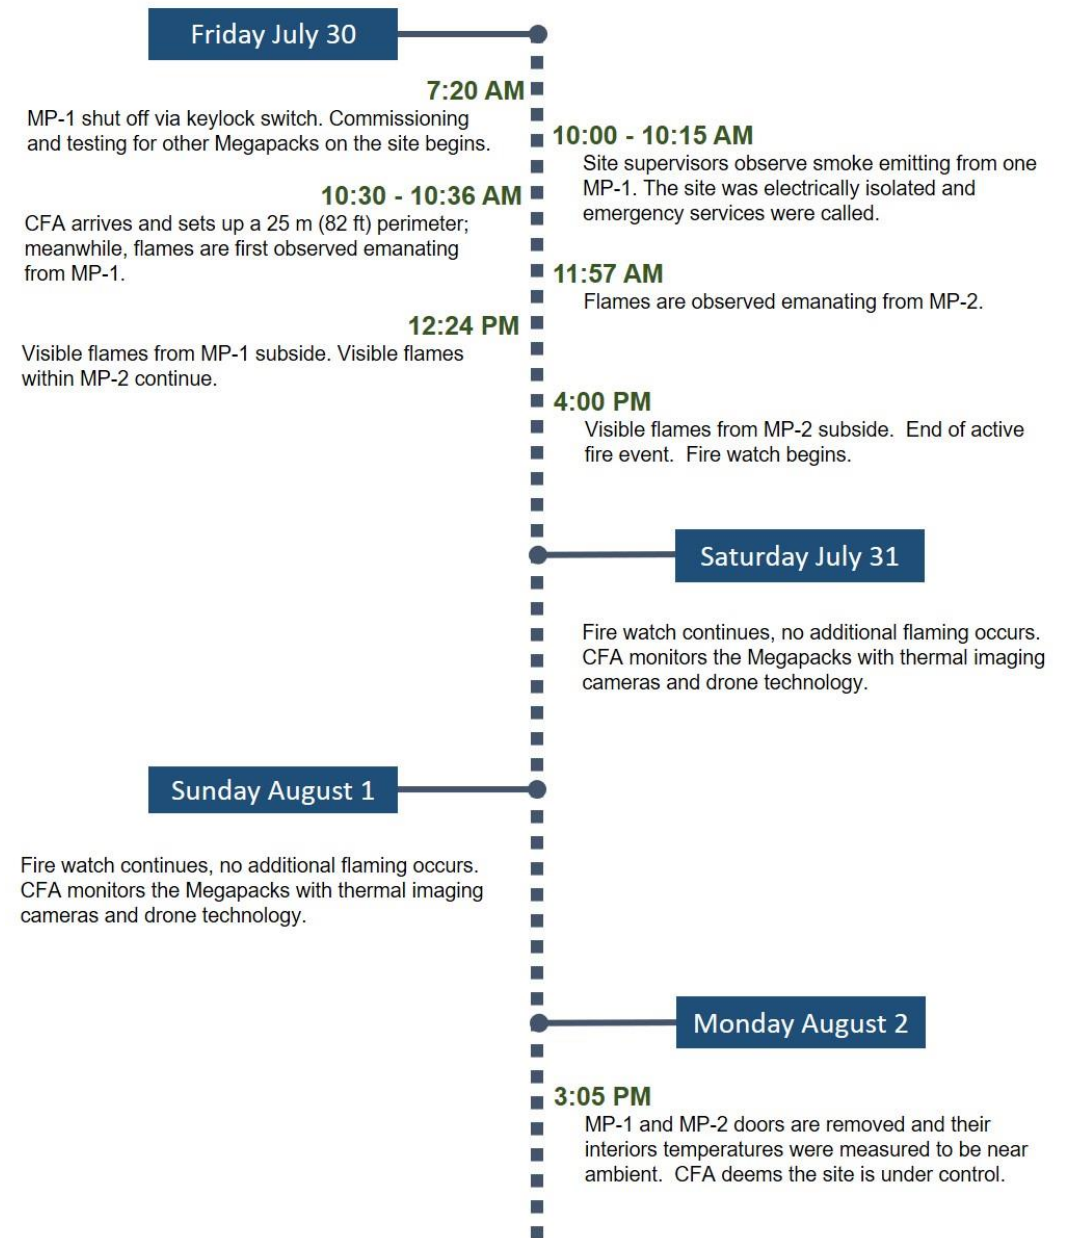
# Incident Timeline

Note: The time stamp is AEST (UTC+10) which is 19 hours ahead of USA PDT (UTC-7)

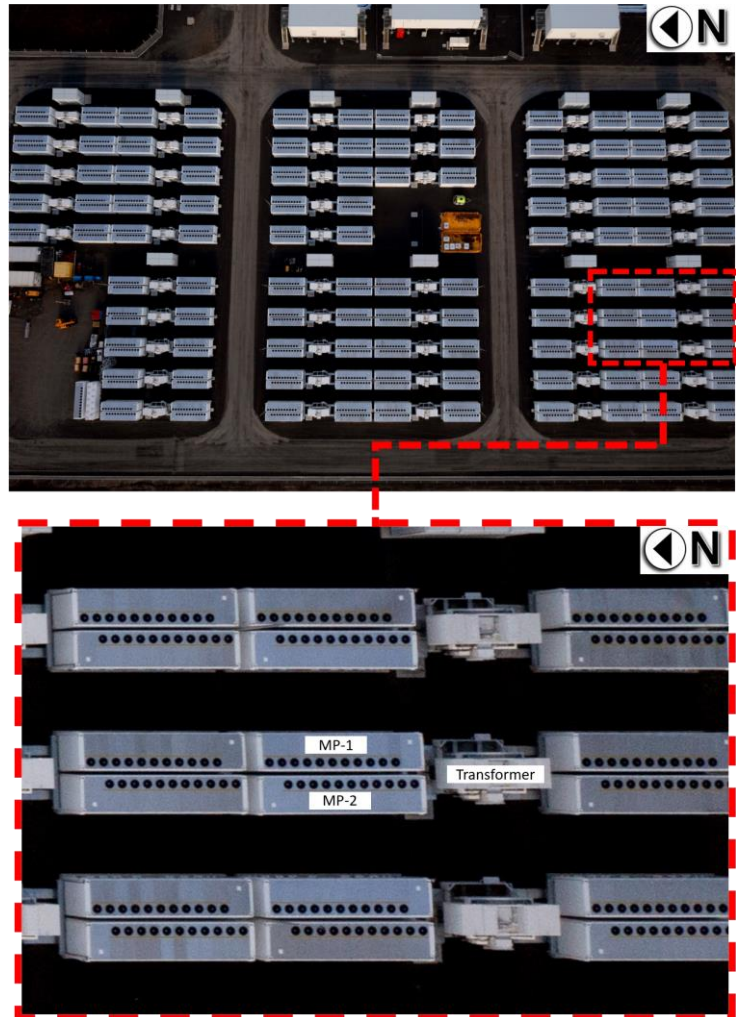
The origin of the fire was MP-1 and the most likely root cause of the fire was a leak within the liquid cooling system of MP-1 causing arcing in the power electronics of the Megapack's battery modules. This resulted in heating of the battery module's lithium-ion cells that led to a propagating thermal runaway event and the fire.

Figure 1 VBB Megapack layout (top) and area of fire origin (bottom)

Flames exiting the roof of MP-1 were significantly impacted by the wind conditions at the time of the fire. Wind speeds were recorded between 20-30 knots<sup>9</sup> which pushed the flames exiting the roof of MP-1 towards the roof of MP-2. This direct flame impingement on the top of the thermal roof of MP-2 ignited the internal components of MP-2, most notably, the plastic overpressure vents that seal the battery bay<sup>10</sup> from the thermal roof. Once ignited, the overpressure vents provided a direct path for flames and hot gases to enter into the battery bays, thus exposing the battery modules of MP-2 to fire and/or elevated temperatures. Exposed to temperatures above their thermal runaway threshold of 139°C (282°F), the cells within the battery modules eventually failed and became involved in the fire.
